Investigation of an electric governor design.

INVESTIGATION OF AN
ELECTRIC GOVENOR DESIGN

Thomas Hazapis,
Lieutenant, United States Navy

Submitted in partial fulfillment
of the requirements
for the degree of
MASTER OF SCIENCE

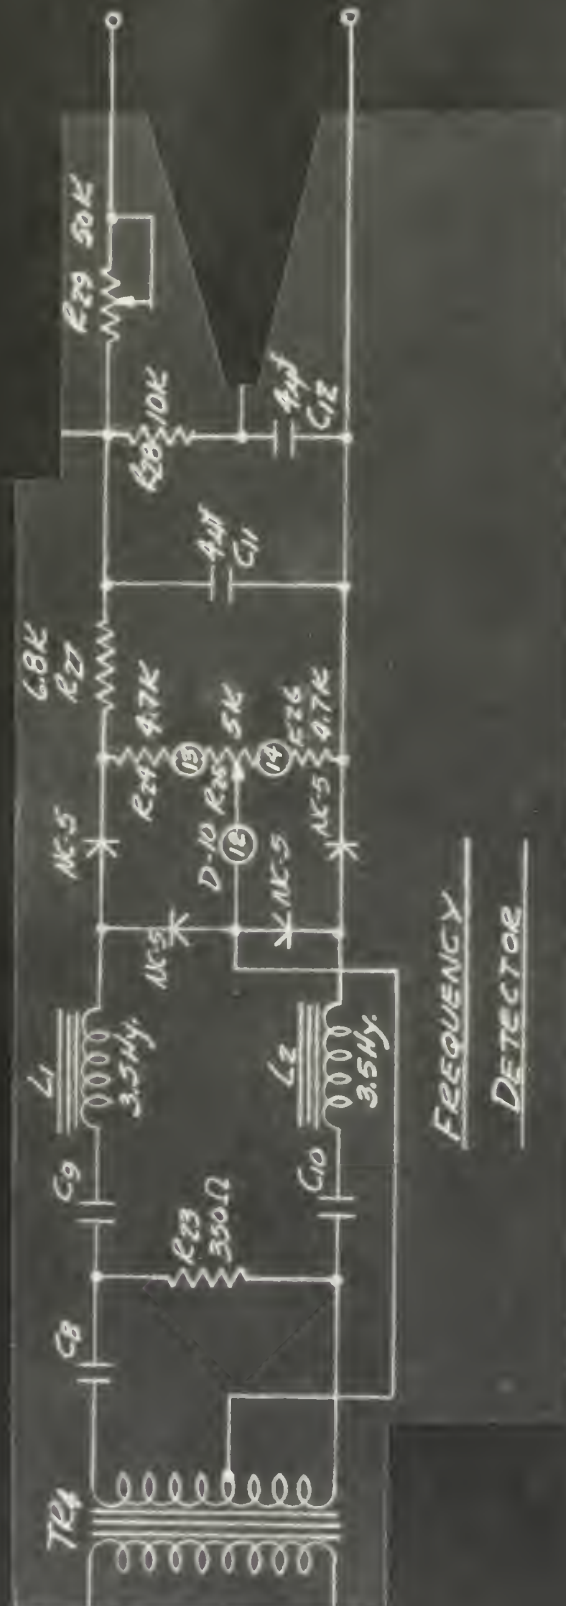
Figure 2.

The frequency detector, figure 2, is essentially a tuned bridge rectifier which supplies direct current proportional in polarity and magnitude to the frequency deviation from 60 cycles. Figure 3 shows the response characteristic of the frequency detector operating into a 5000 ohm load.

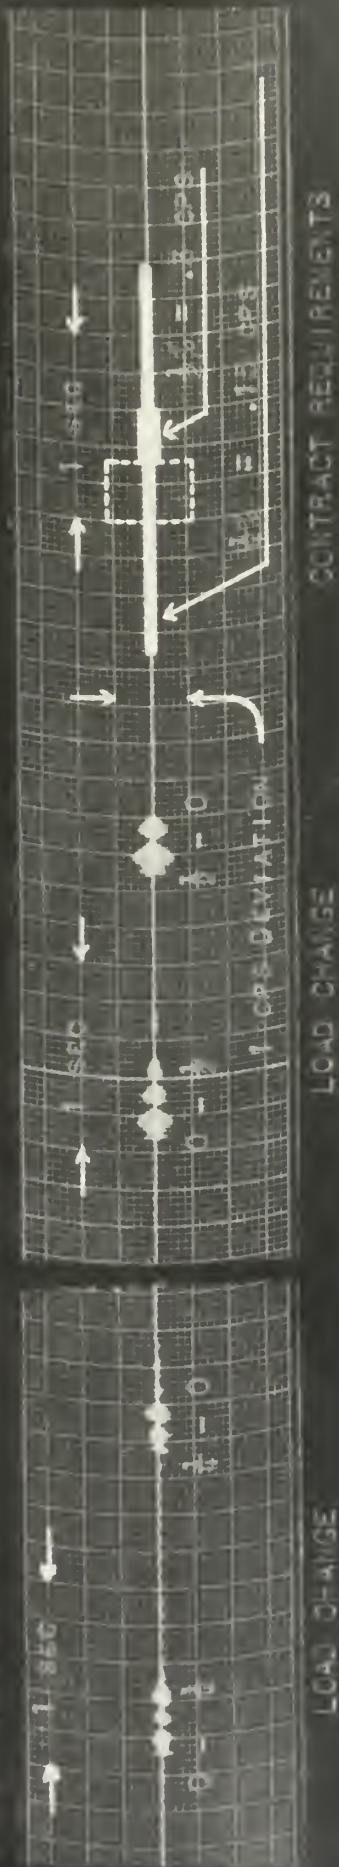
Figure 6.

A 40 kilowatt GM direct coupled diesel generator set was supplied by the U. S. Naval Engineering Experiment Station for testing and adjustment of this system. Figure 6 is a record of the best operation of this system, which will be seen to fall within contract specifications.

OSCILLOGRAMS SHOWING PERFORMANCE OF
VACUUM TUBE ELECTRICAL GOVERNOR

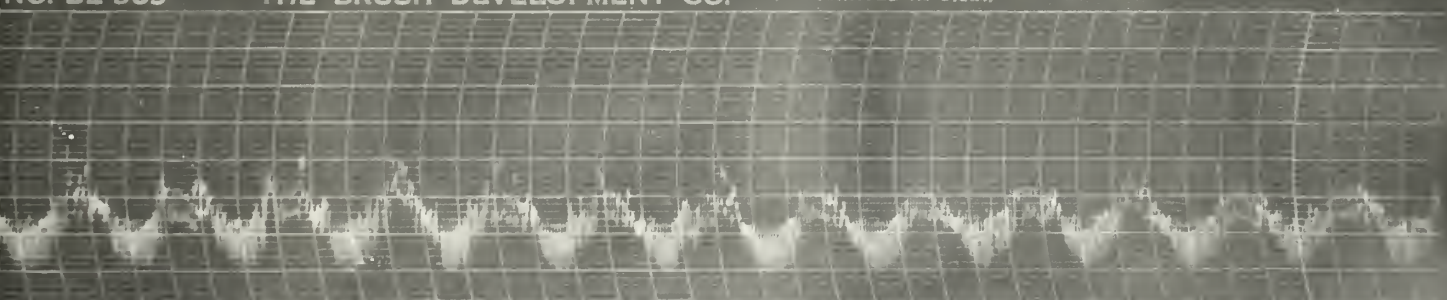
Run D2

1.728 cycles

No feedback

Z_3Z_4 vs output
